## THESIS

**POWER PLANT AND  
DRIVE TRAIN IMPROVEMENTS  
OF THE  
NPS *HUMMINGBIRD*  
REMOTELY PILOTED HELICOPTER**

Robert E. Conway

September, 1996

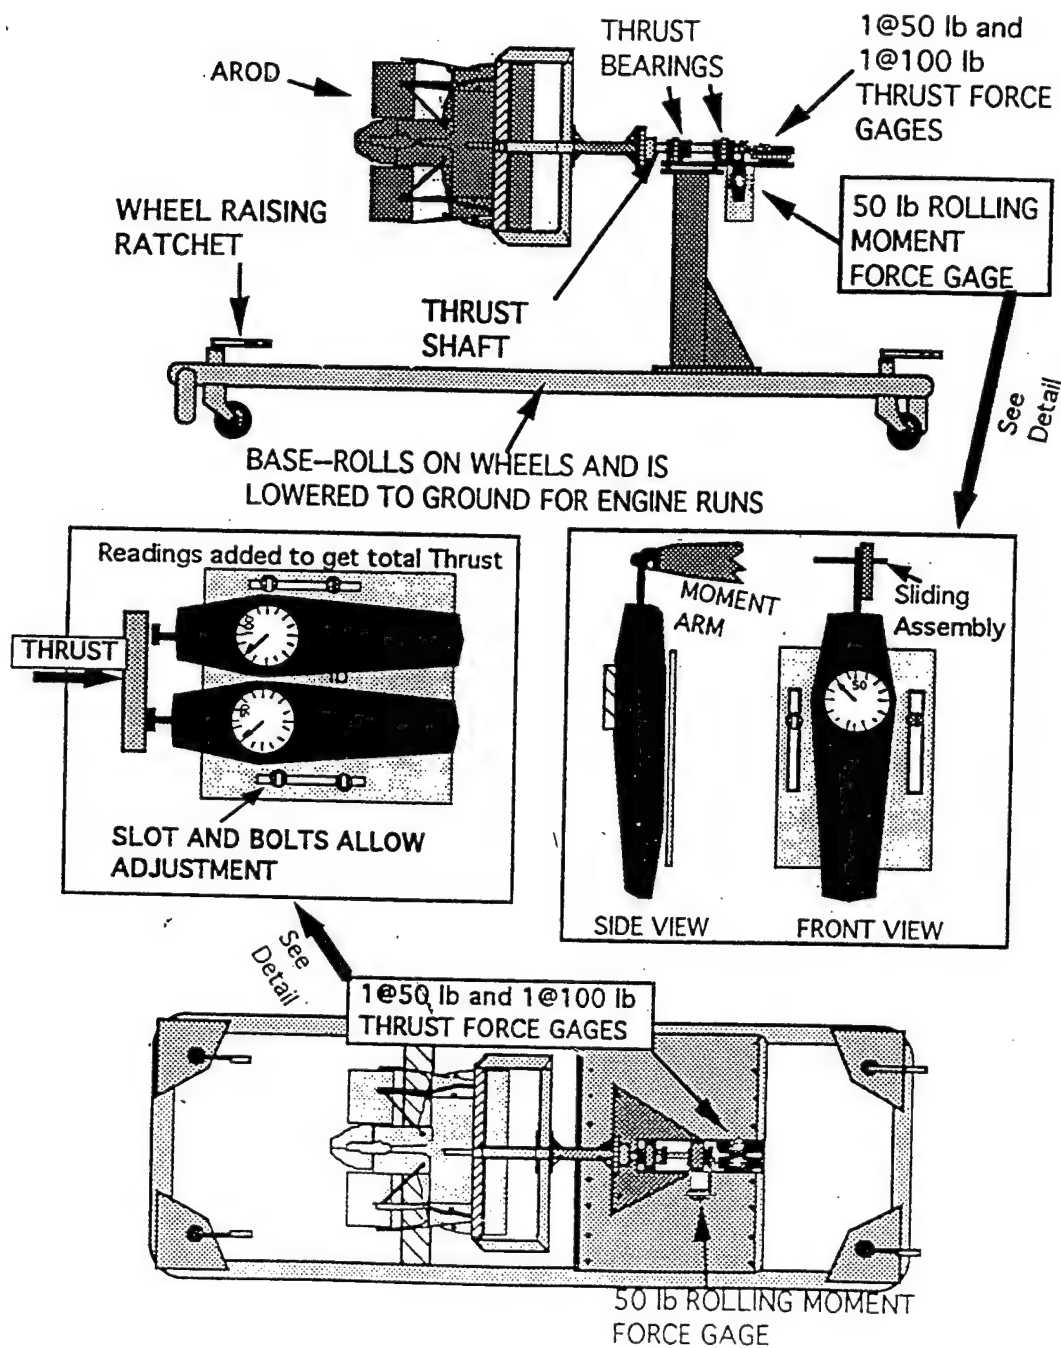
**Figure 7. Engine Test Apparatus**

The engine was mounted on a test stand designed to measure thrust and rolling moment of the AROD UAV. The rolling moment was the only measurement taken and allowed the determination of engine power. Thrust measurements were not needed for the performance calculations. The moment was computed by reading a force gage which was mounted at the end of a 9 inch moment arm, as seen in Figure 7, and then converted to horsepower after obtaining engine rpm by a strobe tachometer. To provide a working load during the testing and break-in procedures a 30 inch diameter birch propeller (commonly used in ultra light aircraft applications) was installed. Figure 8 shows the engine rigged for testing. The direction of rotation of the engine was opposite to the direction of rotation of

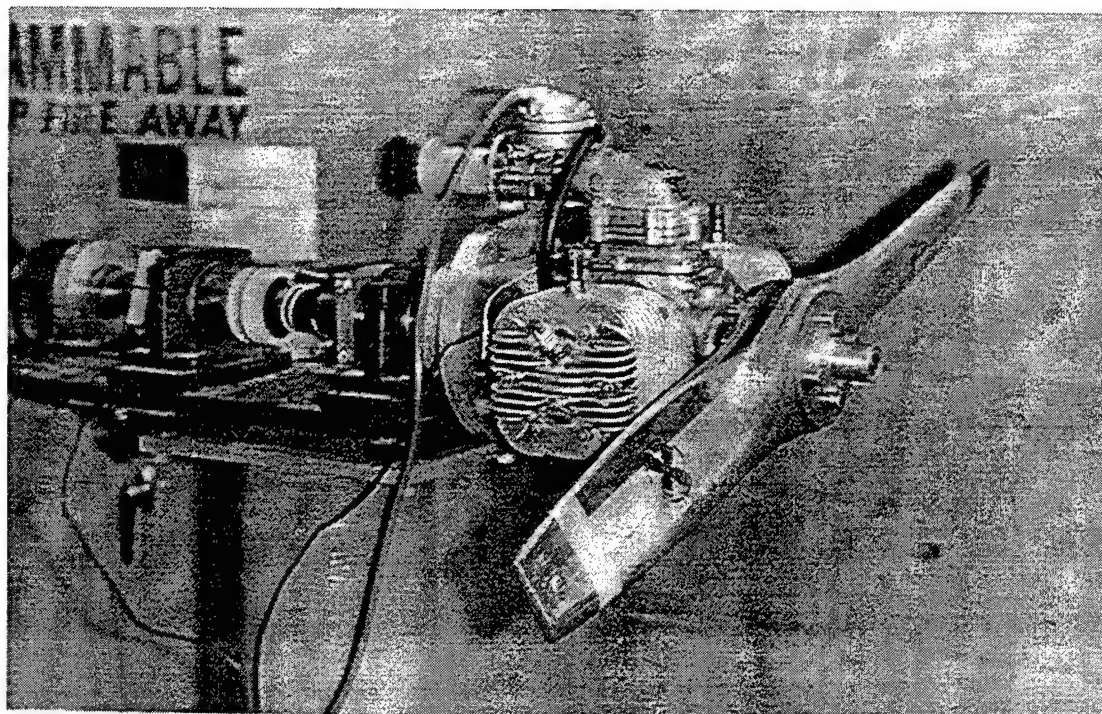
**Figure 8. WAEL 342 in the Test Configuration**

the propeller. For this reason the propeller had to be mounted backwards. A one gallon fuel tank provided a 25:1 fuel-oil mixture to the engine. As a precaution a 24 inch diameter room fan was placed to direct airflow over the engine. This later proved to be ineffective.

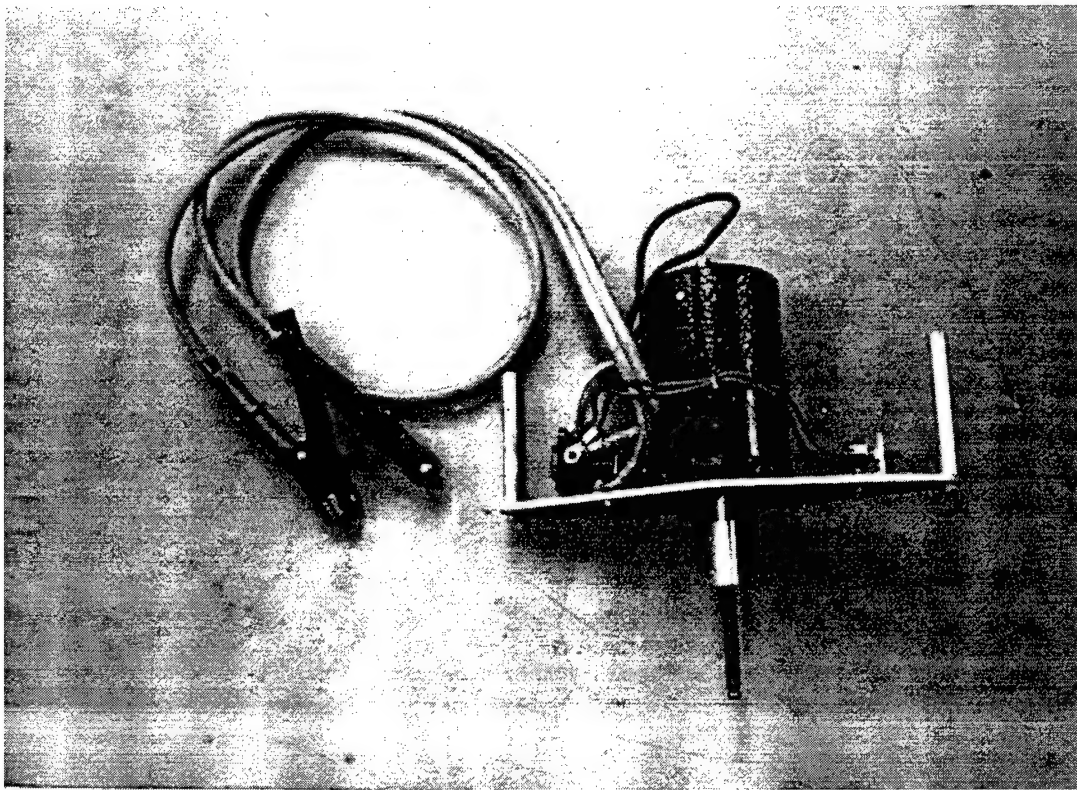
**Figure 9. Hand-held Starter**

The engine was started by a hand-held starter which contained a new starter motor shown in figure 9. With the need to start the engine in a counter-clockwise viewing the engine from the rear on the test stand, a starter with this rotation was sought. Also at this

stage of the research the direction of rotation of the external starter design had not yet been decided. Therefore a starter with the capability of providing adequate torque in both directions was prudent. The Prestolite MBJ-4407 winch motor was chosen for its availability, power and dual directional capability. The performance specifications for this motor can be found in appendix C.

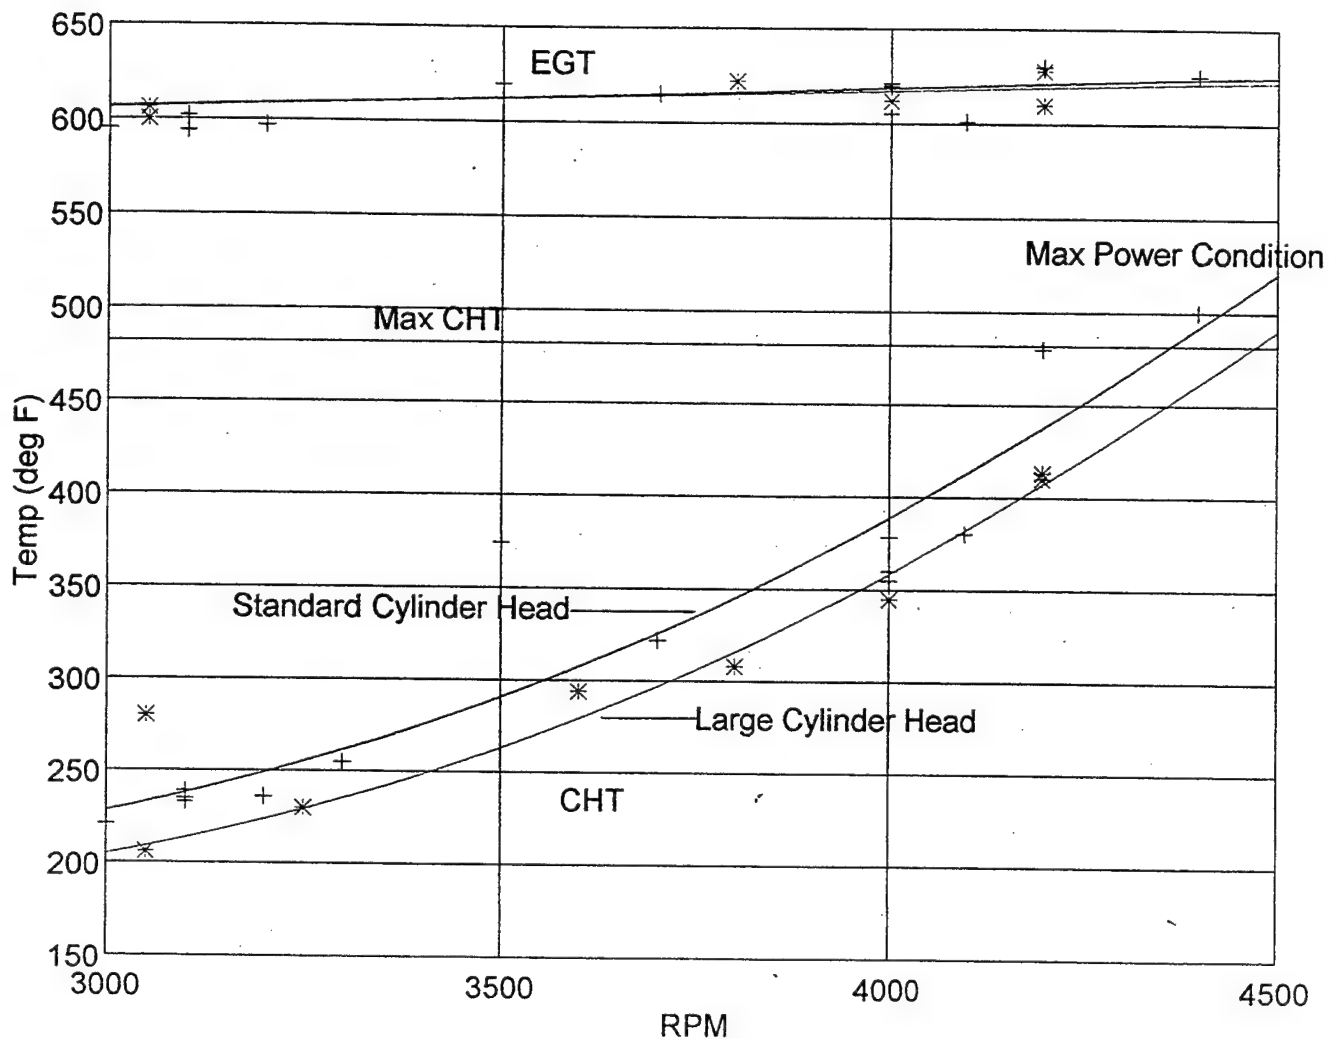
**Figure 10. CHT Comparison for Large and Small Cylinder Heads**

The engine was again tested in static air conditions. Runs initially at idle power settings showed an approximate 25°F decrease in CHT and, as expected, no change in EGT. Runs at maximum throttle showed a maximum CHT of 435°F. The effect of the increased

area of the cylinder head reduced the maximum CHT by over 47°F in static conditions. A comparison of the EGT and CHT observed with the two sizes of cylinder heads is shown in Figure 10.

This determination moved the cooling system design away from a high mass flow system to an interior ventilation or low mass flow system in which the induced air flow velocities over the engine on the test stand would be matched or increased inside the fuselage.

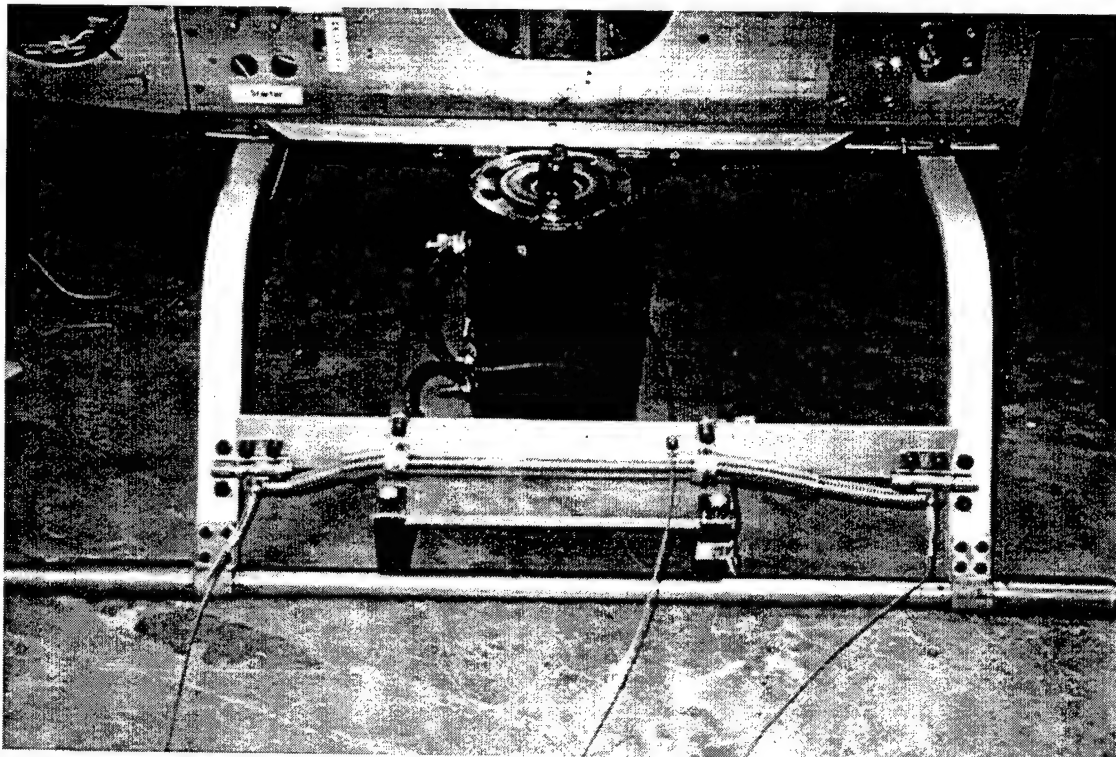
**Figure 13. Starter Mounted to Landing Gear**

The starter is held in place at four points shown in Figures 13 and 14 keeping entirely off the ground when attached for engine start. The first two are on each landing gear strut. Two pins and mechanical stops prevent fore and aft as well as lateral movement. These two

pins are connected by a spring so that both pins release after an over-the-center lock is cleared. The third point is the 3/8 inch hex ball socket which limits horizontal planar movement when coupled to the engine. The fourth point is a spring-loaded latch assembly connected to a cross bar under the engine which keeps the starter coupled to the engine during start. Two 30 foot lengths of small diameter cable are connected to the assembly which allows starter disengagement and towing the assembly clear of the operating area. Skids are installed to pull the assembly clear. The skids are formed with a semi-circular protrusion on the front. This feature unloads the 20 pound weight on the pins that hold the

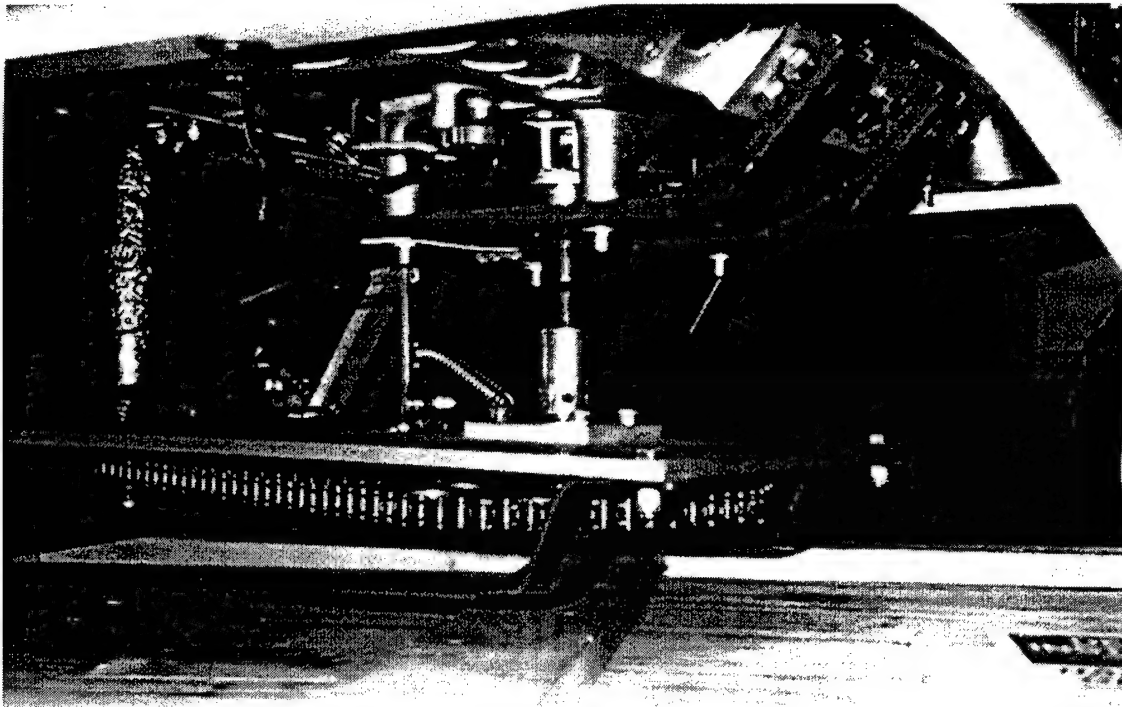
**Figure 14. Starter Coupled to Engine**

starter assembly to the landing gear skids when the starter is disengaged from the engine to ease in the pin release.

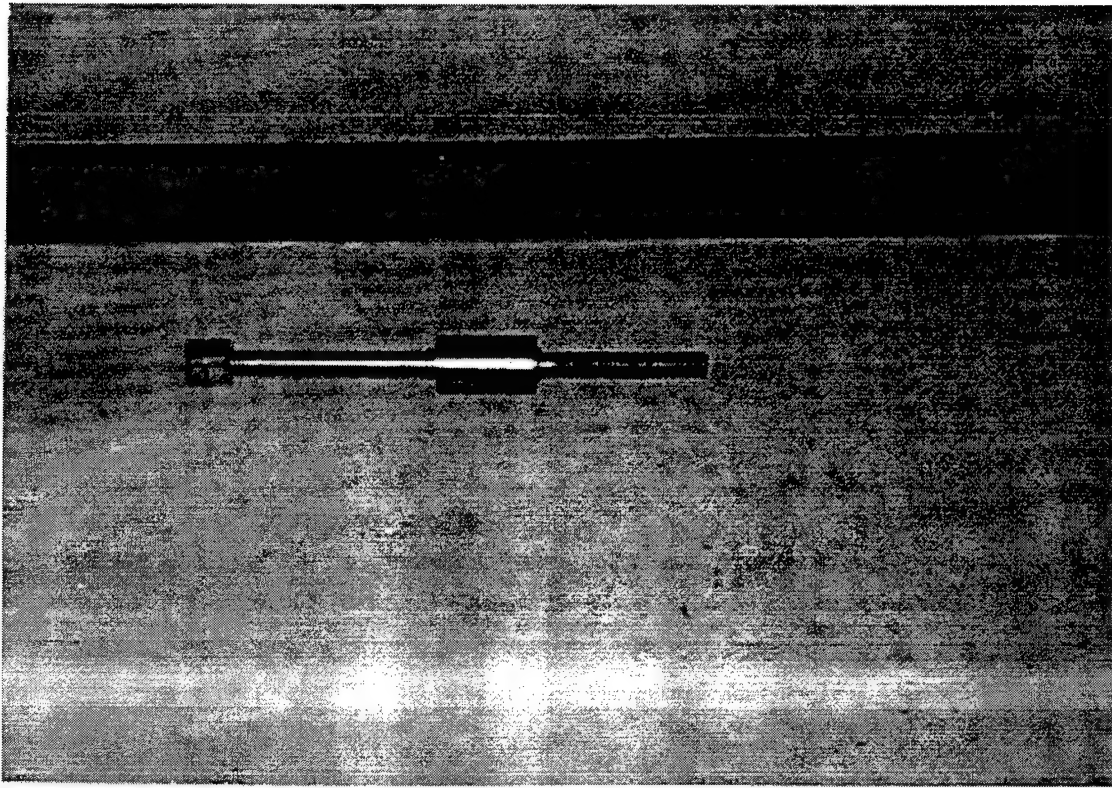
**Figure 17. Spacer Bolt**

The bracket modification led to another problem. The upper engine mount braced the engine through two of the six 6 mm cylinder head bolts. There existing cylinder head bolt was not long enough to provide support for the cylinder head and also pass through the upper engine mount. Attempts to find longer bolts and 6mm threaded rod failed as no local supplier carried the longer bolts or metric size threaded rod. As a result, two adapters which acted as a cylinder head bolt, spacer and upper engine mount attachment point were designed to custom fit this application. Figure 17 shows this piece. The cylinder head bolt segment is 6 mm in diameter and includes the correct cylinder head bolt thread length. The spacer was designed to provide a gap between the cylinder head and upper mount brace so there will be no damage inflicted on the cylinder head heat fins while the both the engine and airframe vibrate. The remainder consists of the mounting bracket threads which are also 6 mm in diameter.

against each other on the mounting bracket end and then the whole piece torqued to the cylinder head bolt torque specification. The two nuts are then removed and the mounting bracket is then slid over the free end. The mounting bracket is then secured by a two lock washers and nuts.

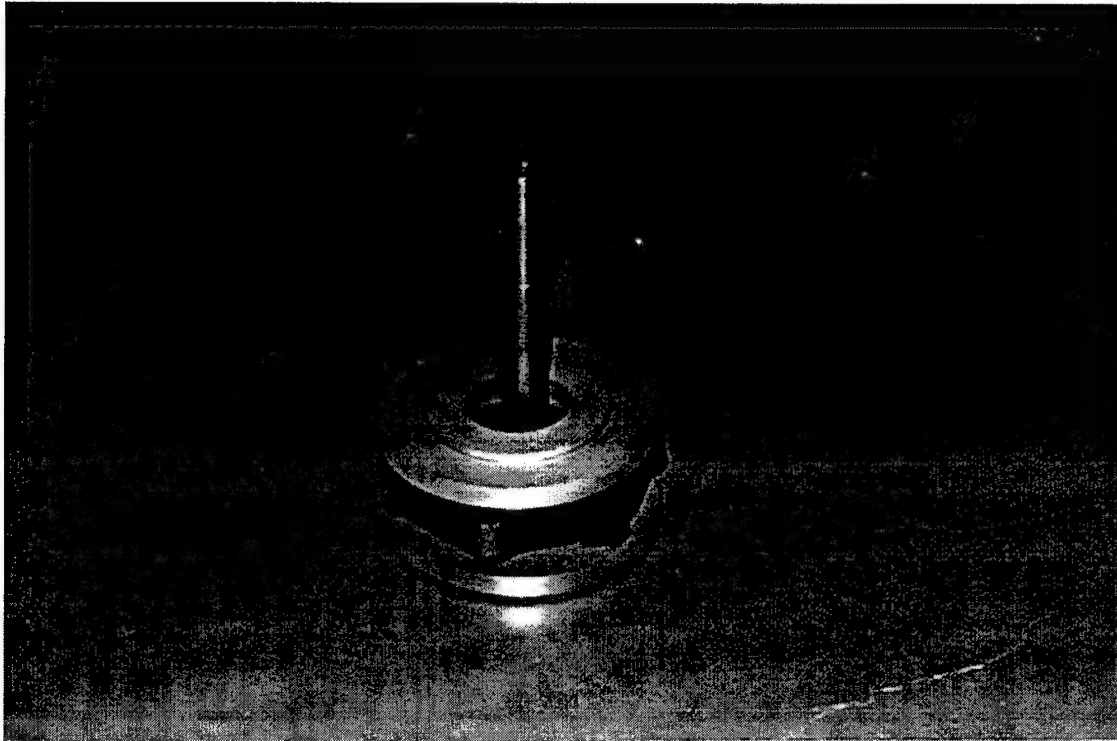
**Figure 20. Layout of Shock Absorber Components**

Due to unforeseen delays the shock absorber was unable to be installed. The installation calls for the upper plate and spacer ring to be mounted directly to the gear's web by four small bolts. A needle bearing is to be pressed into the inside of the drive gear allowing it to move freely about the shaft. The Rotoflex® coupling is then bolted to the upper plate and the lower plate bolted to the coupling. After the shaft keys and snap ring is in place, the assembly is then placed into the transmission. The Figure 20 shows the

unfinished components of the shock absorber system in the position they are to be mounted.
